# PLEASANT BAY COMMUNITY BOATING FALL SPEAKER SERIES

## Pleasant Bay: A Focus on Environmental Stewardship

Robert A. Duncanson, Ph.D.  
Retired Director of Health & Natural Resources  
Town of Chatham

# MUDDY CREEK RESTORATION BRIDGE PROJECT

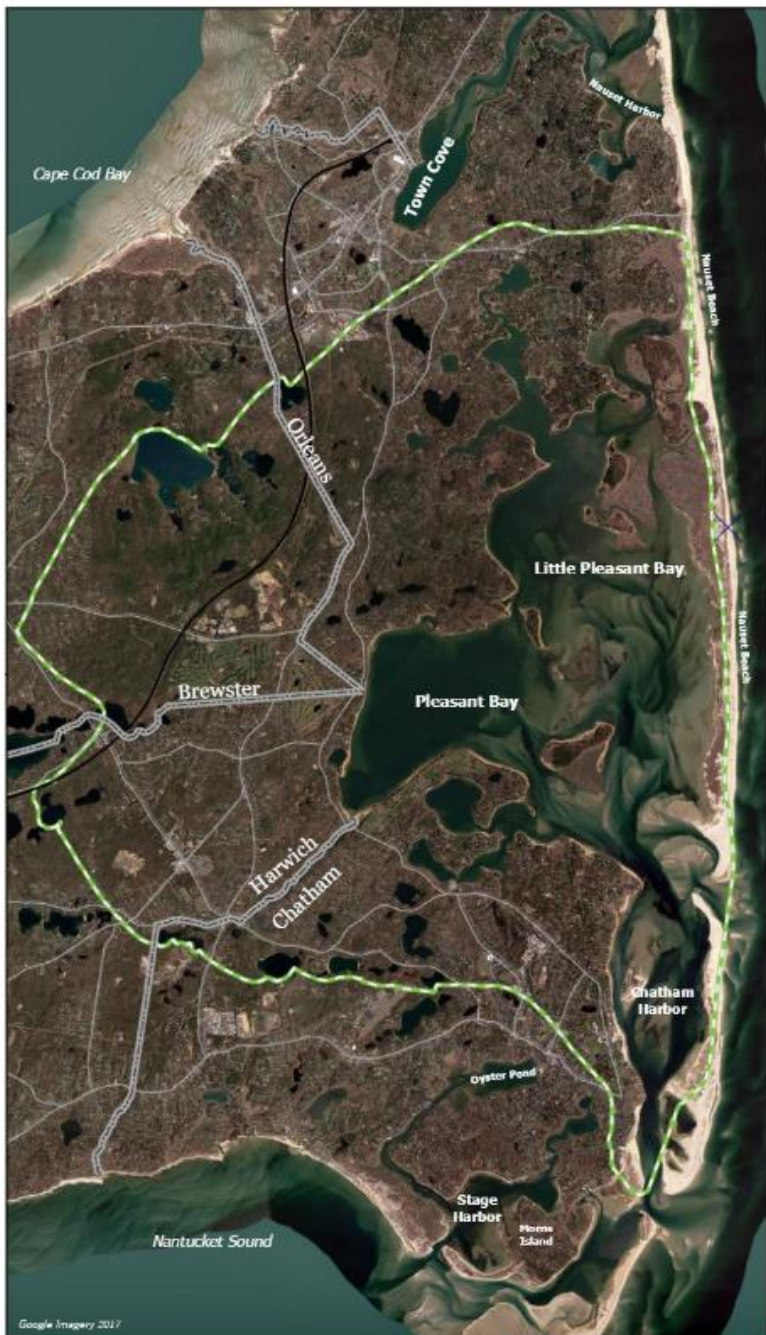
Pleasant Bay Watershed

Marine Water Recharge Area (Watershed)

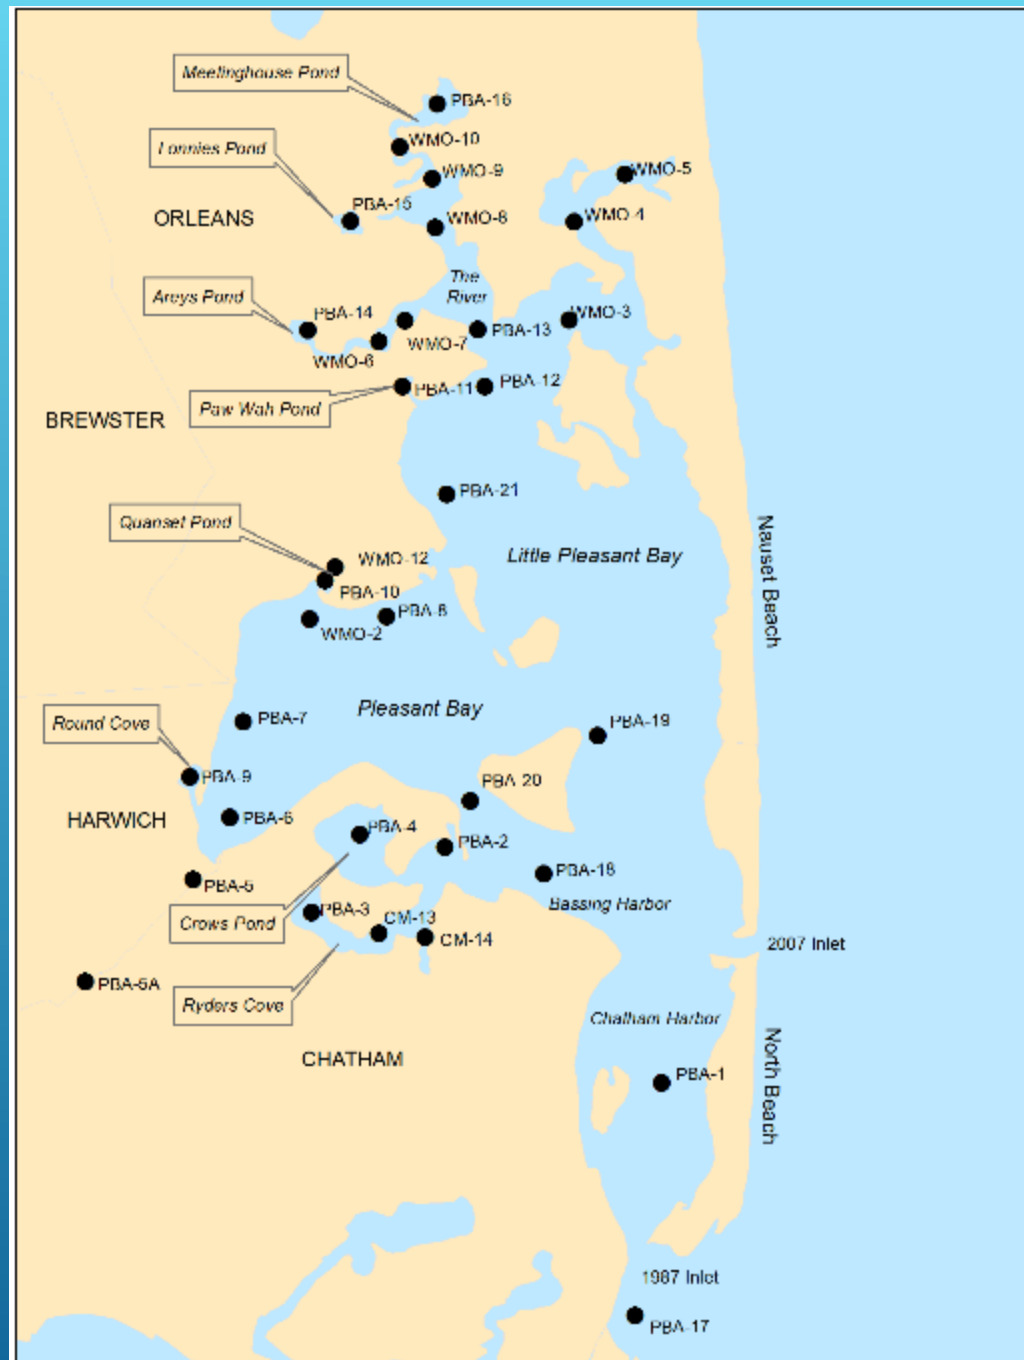
- 25+ monitoring stations throughout the main basin and sub-embayments
- Samples collected from 2000 through 2024
- Minimum sampling frequency is twice in July and August and once in September
- In addition to in-situ measurements, samples are transported to UMass Dartmouth for analyses.

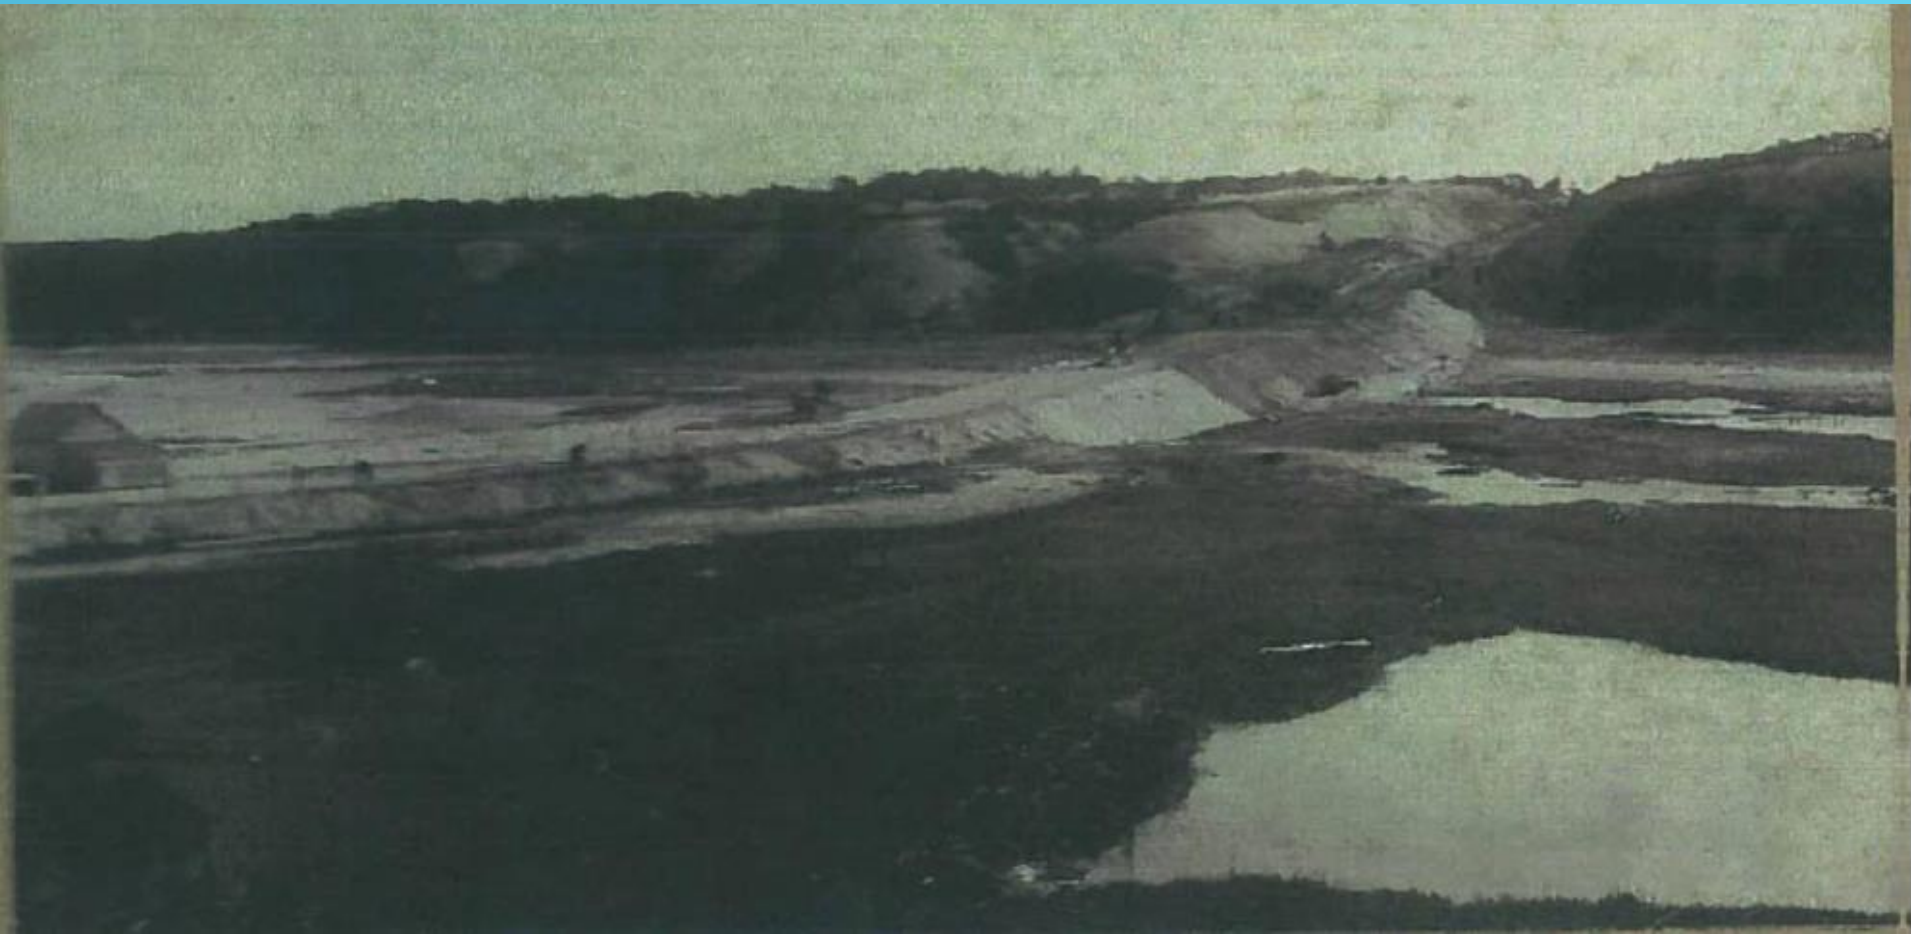
Historic photo of earthen fill placement at Orleans Road (Route 28) over Muddy Creek, facing south toward Chatham circa 1900

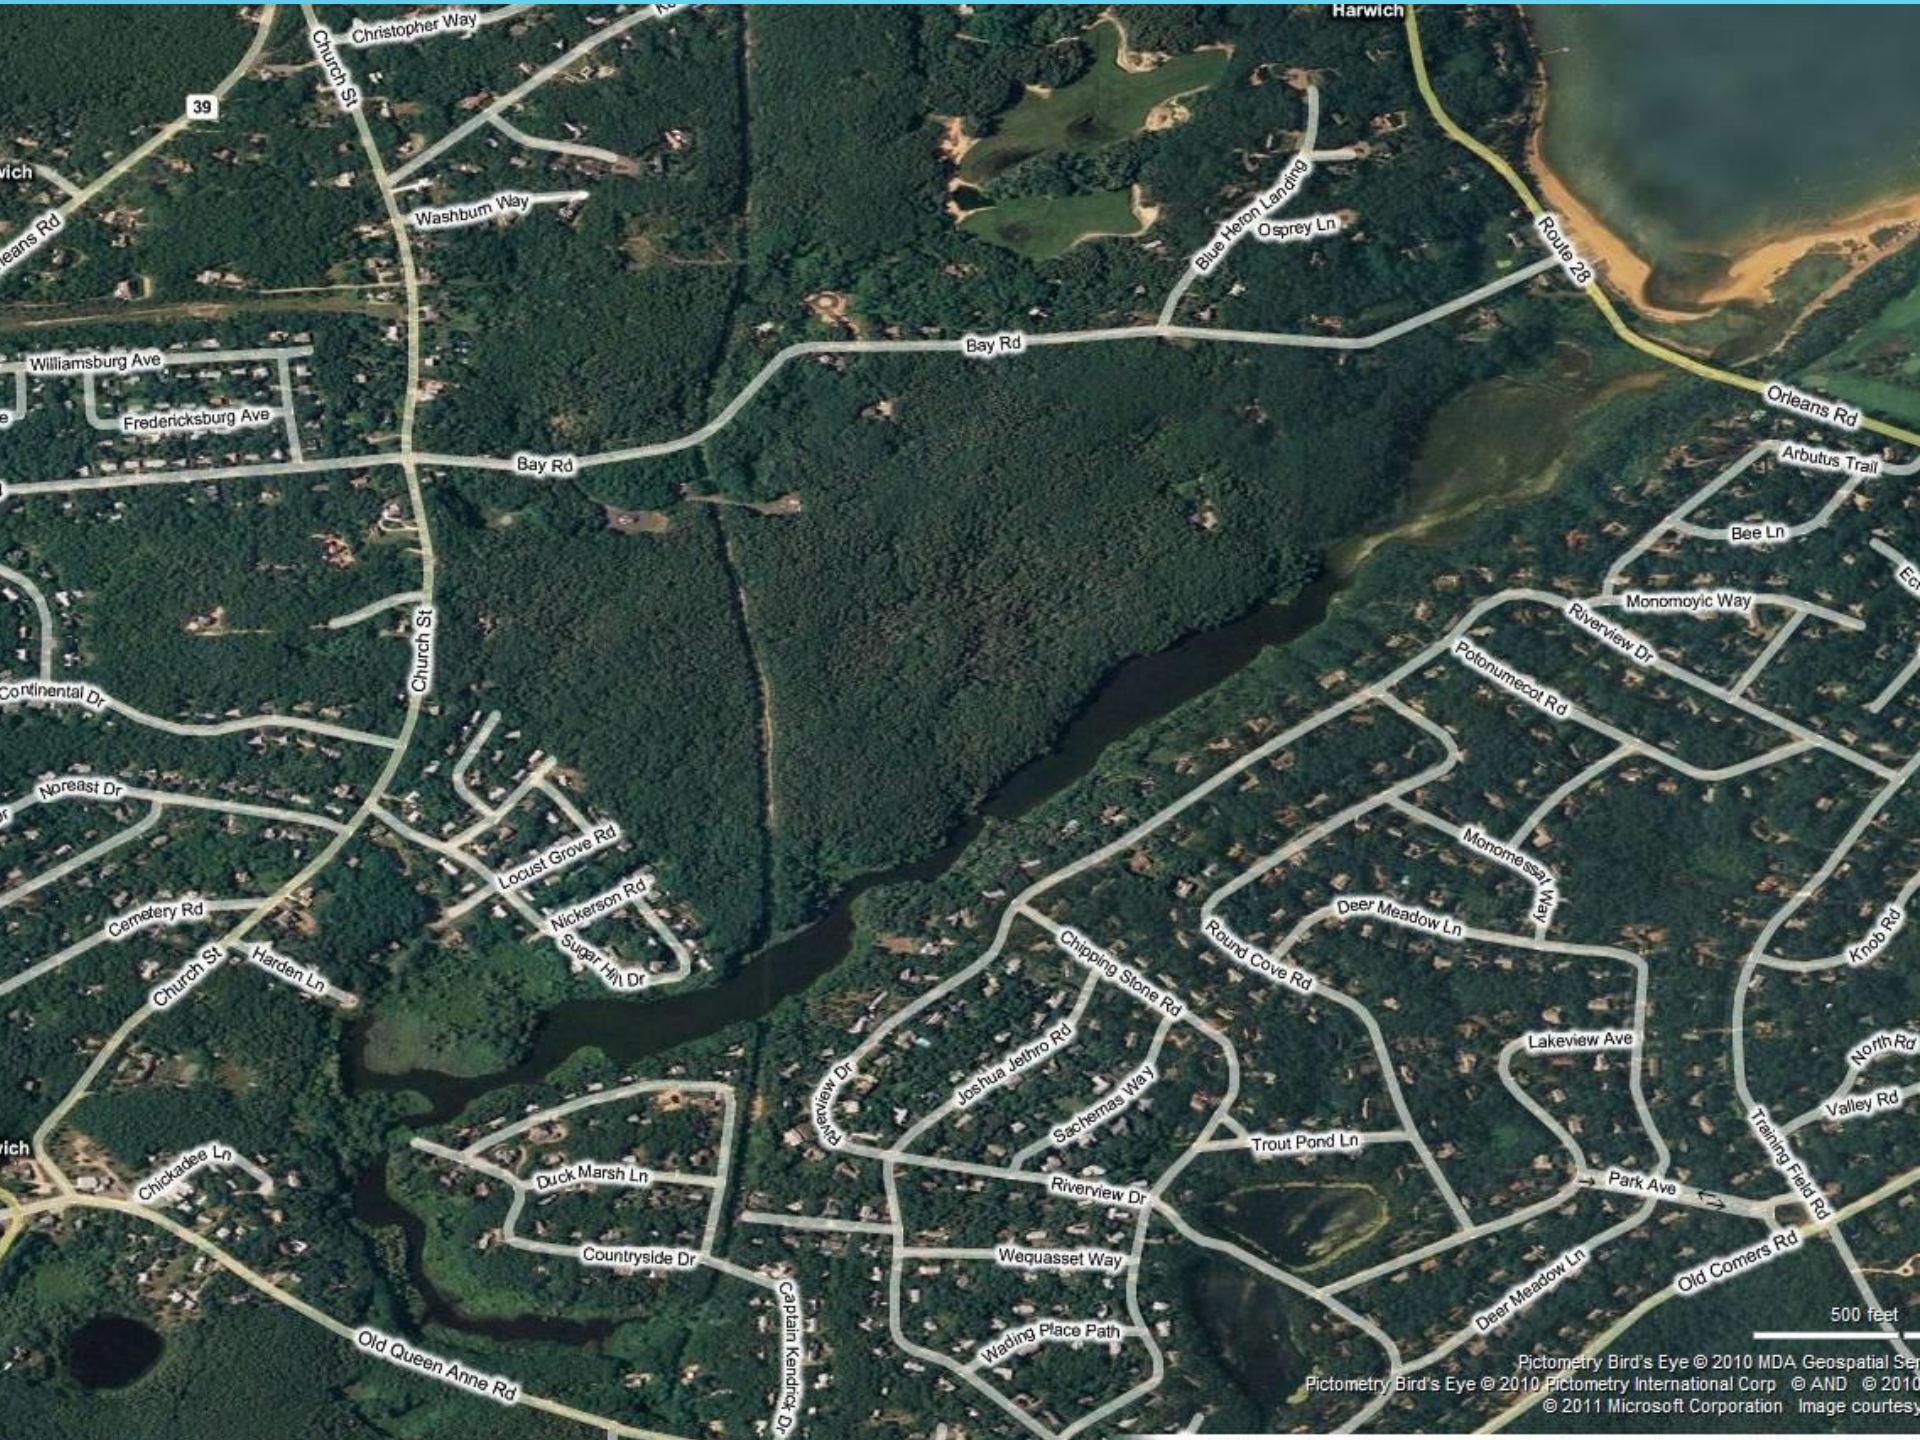
- ❖ Restricted tidal flushing
- ❖ Poor water quality
  - Total Nitrogen TMDL
  - Bacterial TMDL
- ❖ Wetlands impacts
  - Loss of marine wetlands
  - Introduction of invasive species
- ❖ Shellfish Closures
- ❖ Limitations on fish passage
- ❖ Limited public water access

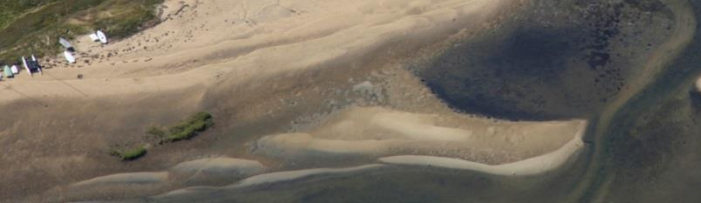
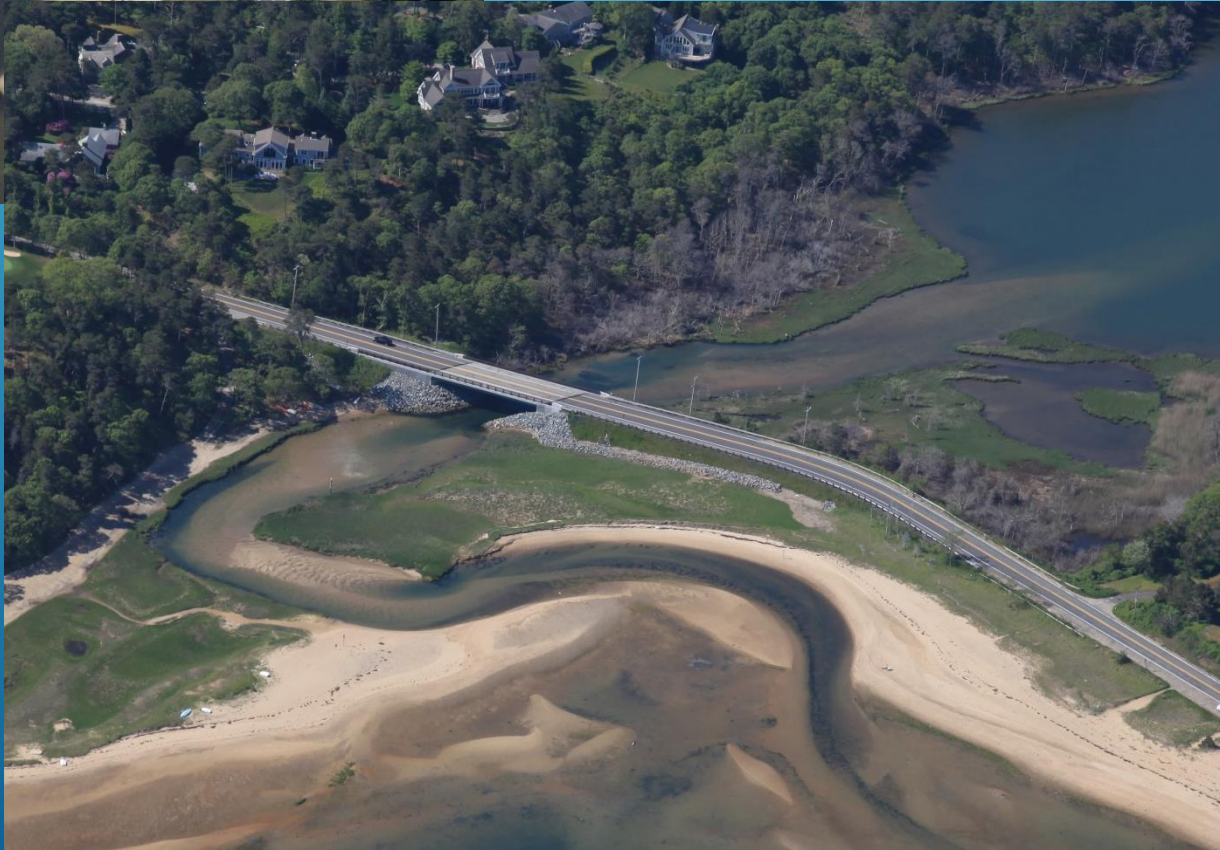
September 11, 2014

June 11, 2017

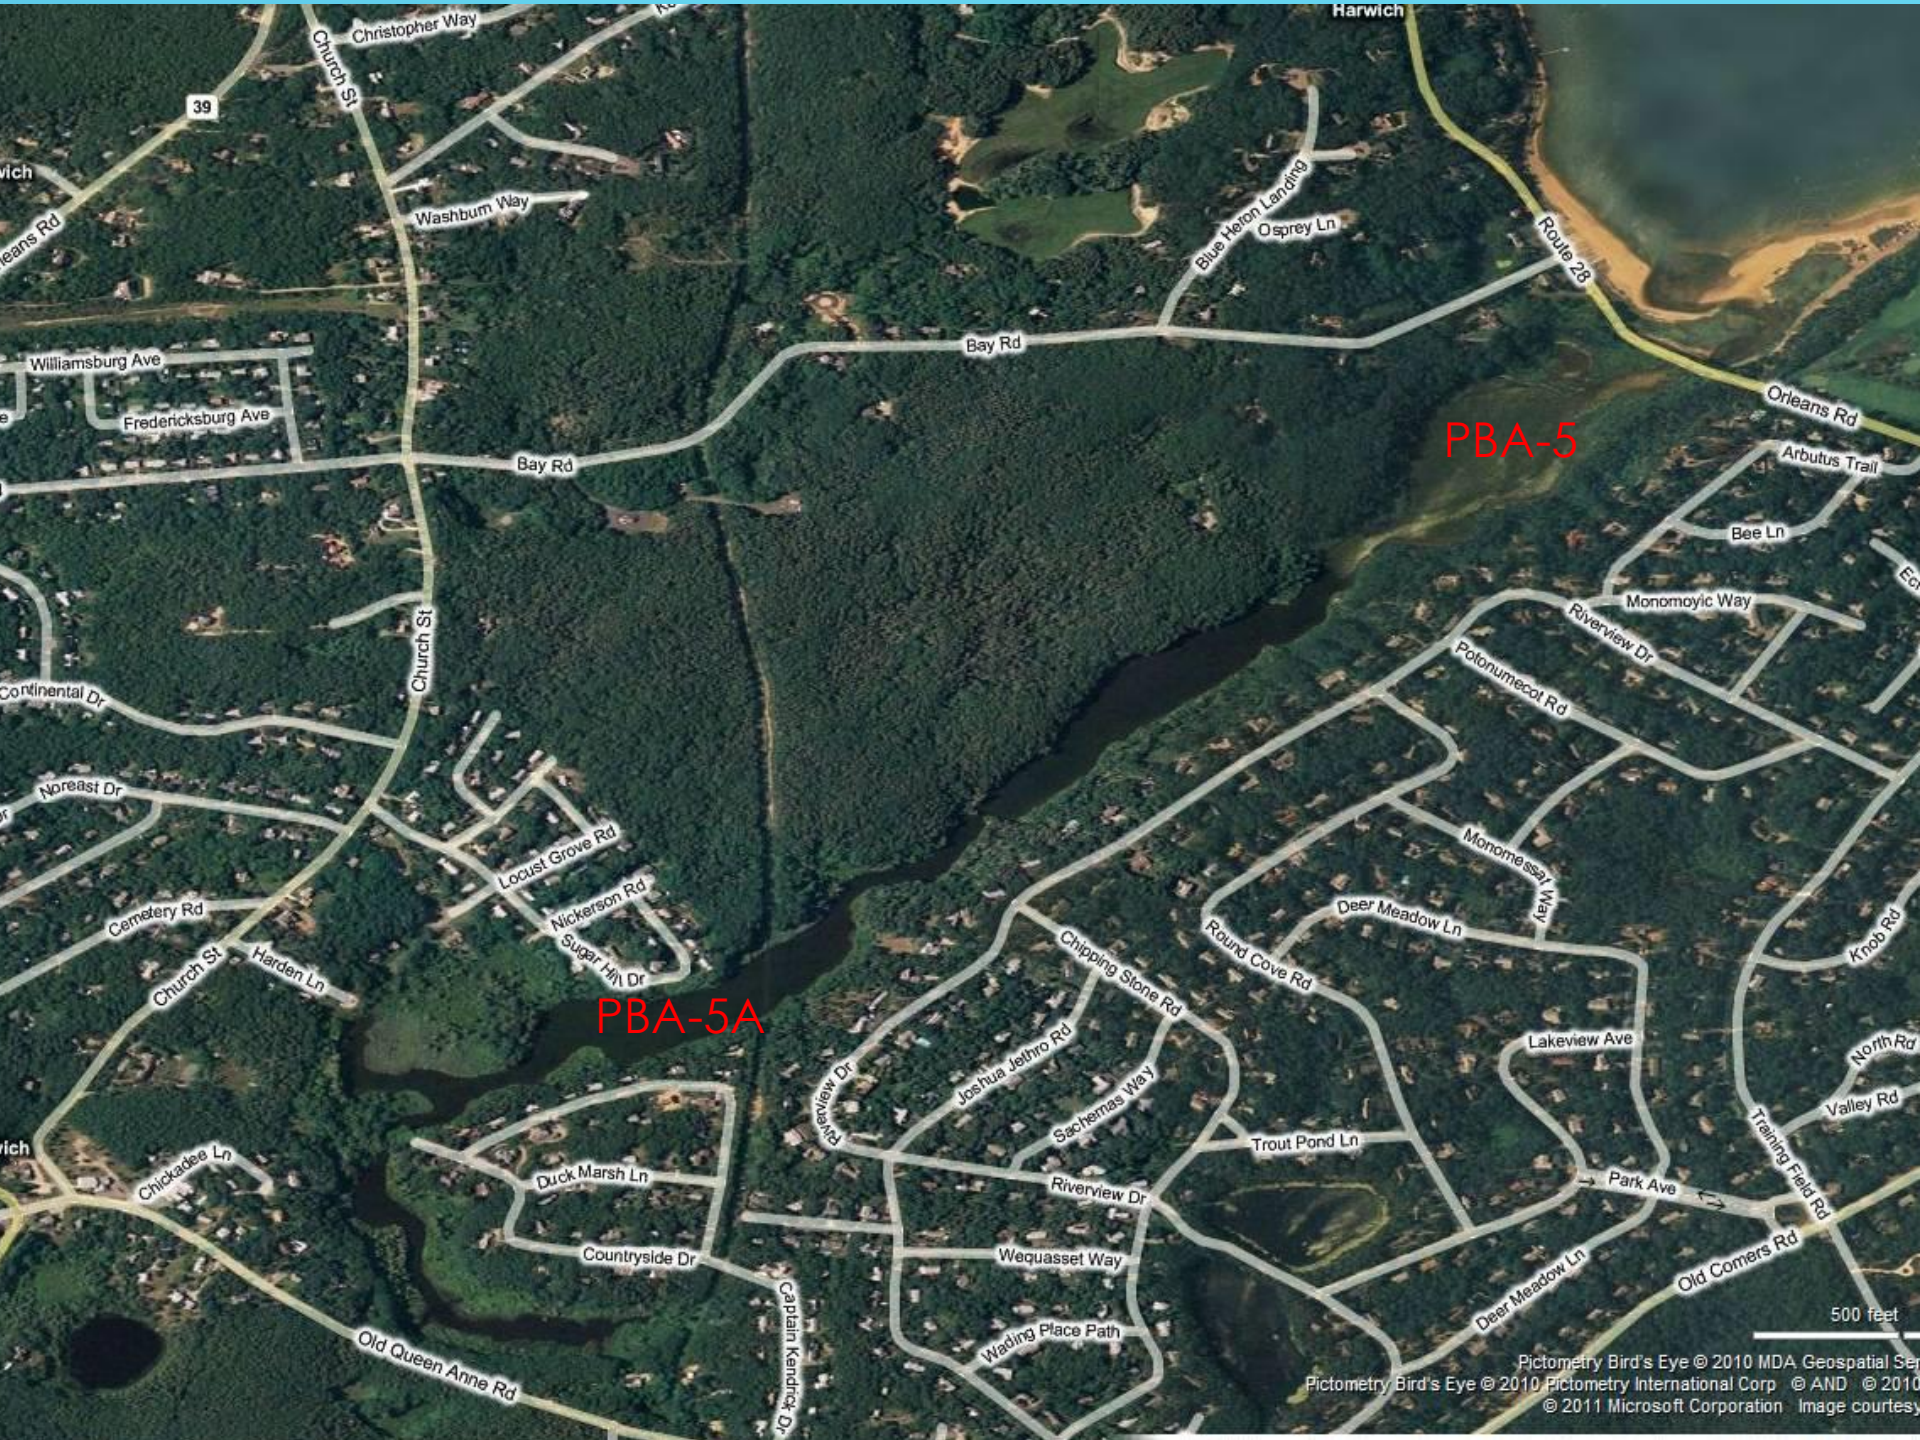
PBA-5

PBA-5A

# Muddy Creek Salinity
